# Investigating rockfall failure configurations using terrestrial laser scanner (TLS)

*Julie D'Amato, Antoine Guerin, Didier Hantz, Michel Jaboyedoff*

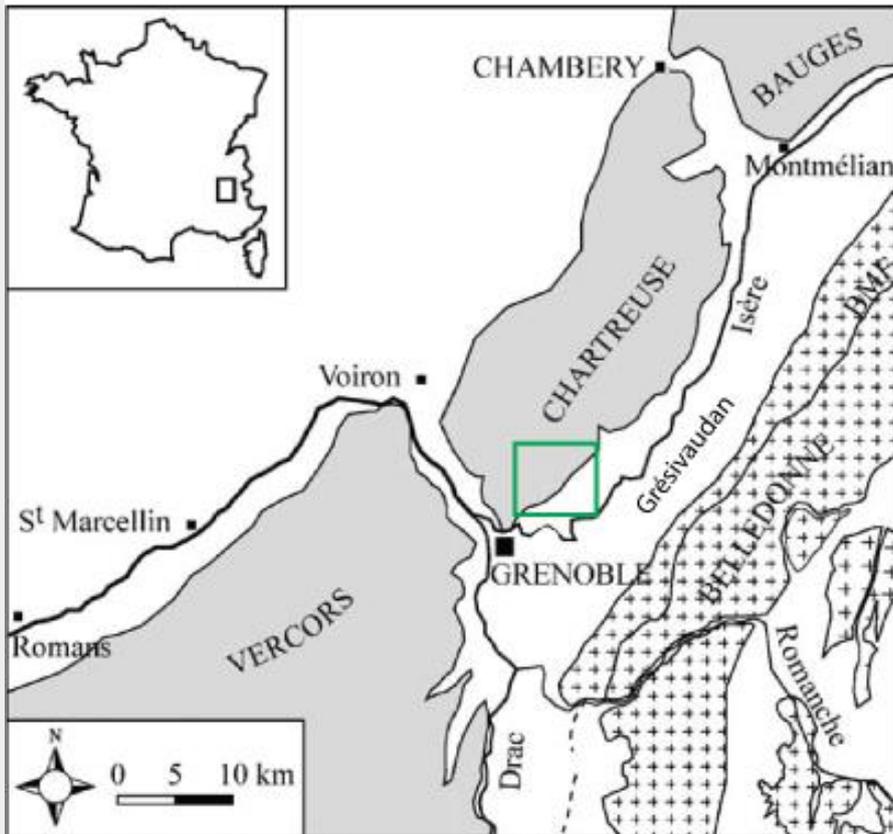
Shaded: sedimentary massifs  
Cross pattern: external crystalline massifs  
BMF: Belledonne Middle Fault  
(after Frayssines, 2006)

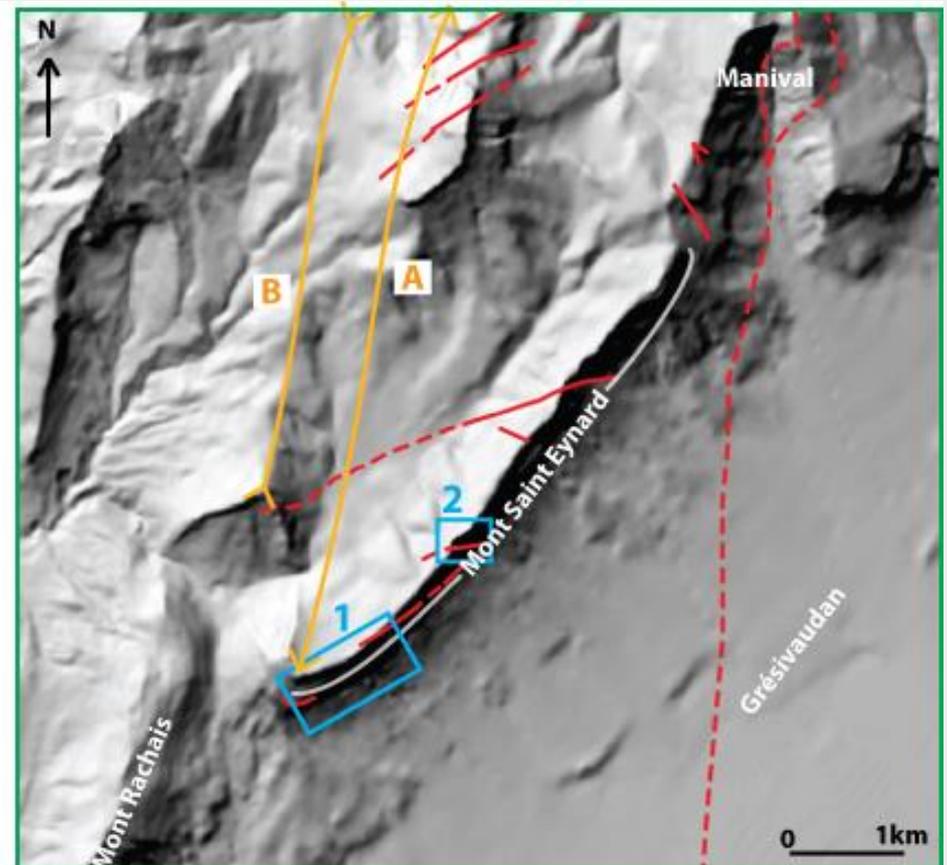
A: Sappey syncline  
B: Ecoutoux anticline  
Continuous and dashed red lines: faults  
Blue squares: TLS investigated zones

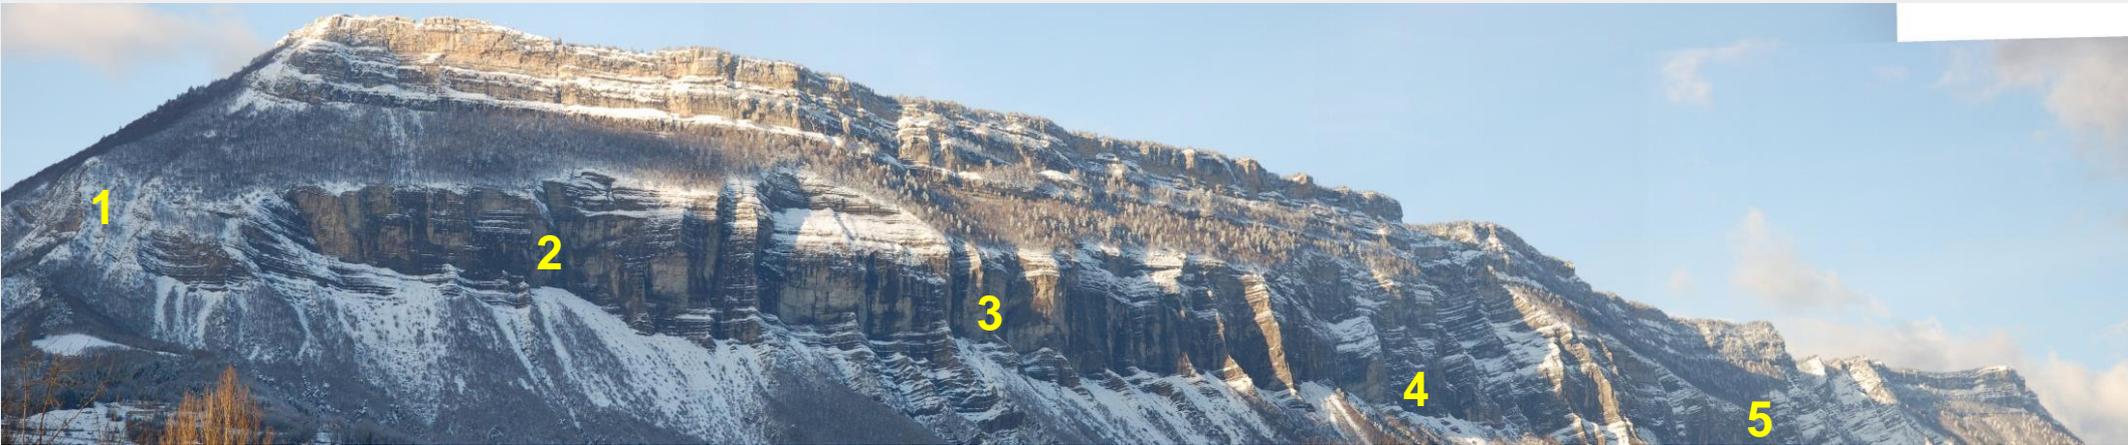
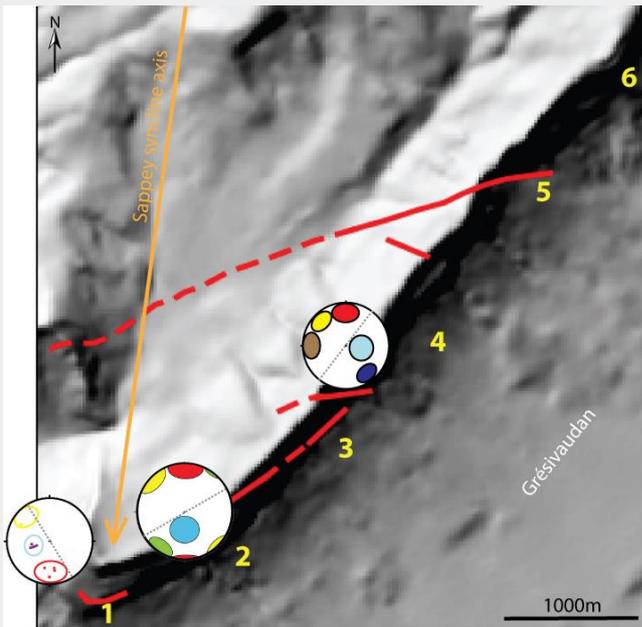
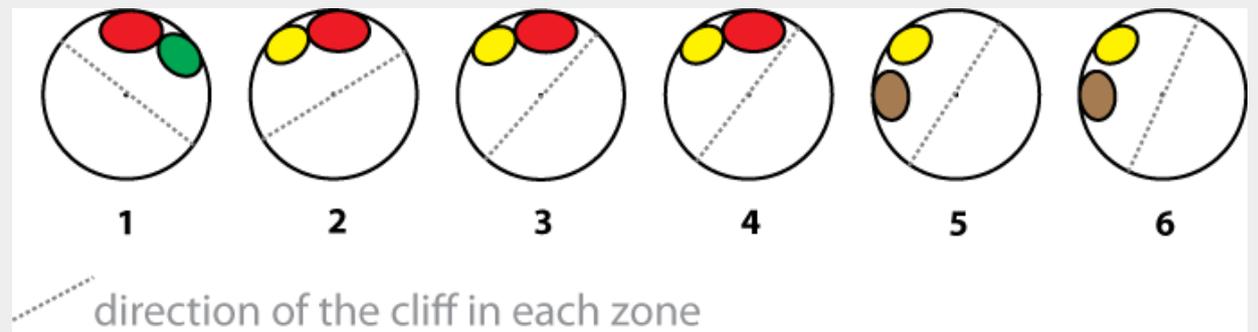
Structural field measurements  
and structural analysis from TLS data

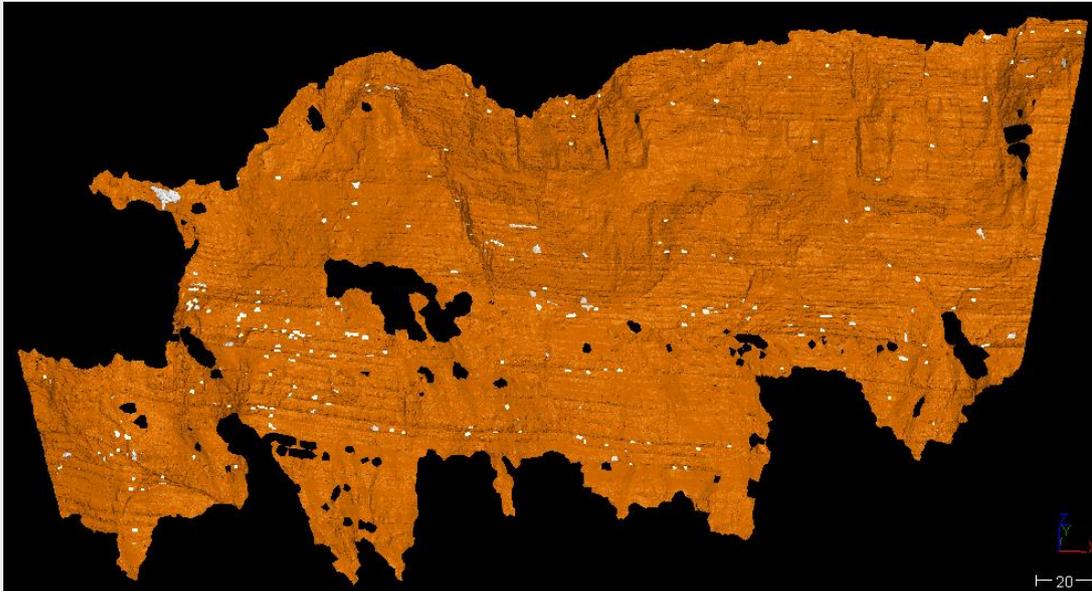
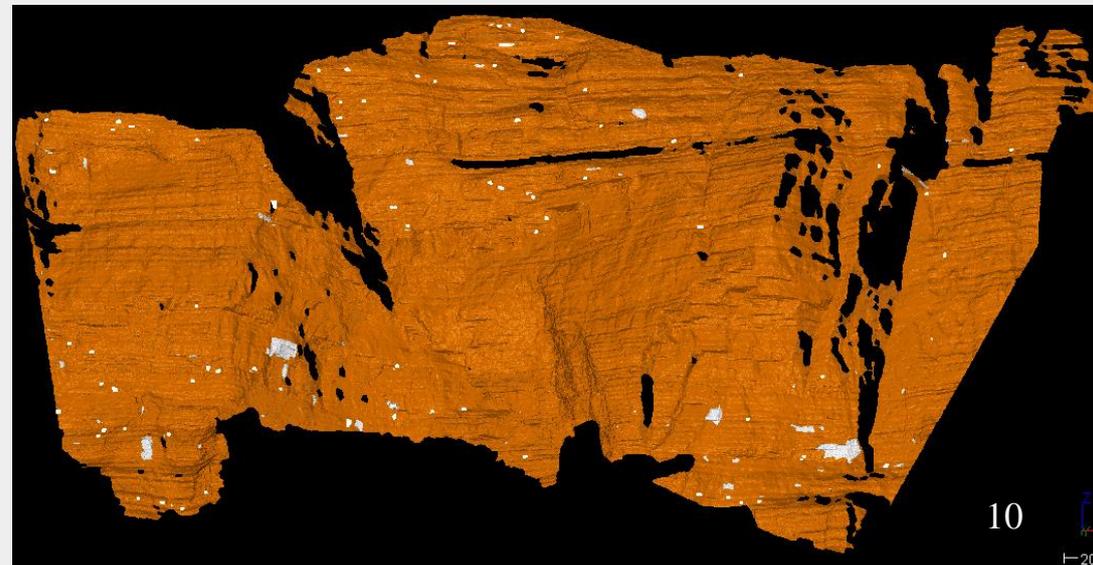
162 studied events

Volume range:  $0.01\text{m}^3$  to  $100\text{m}^3$

75% of the rockfall volumes smaller than  $1\text{m}^3$

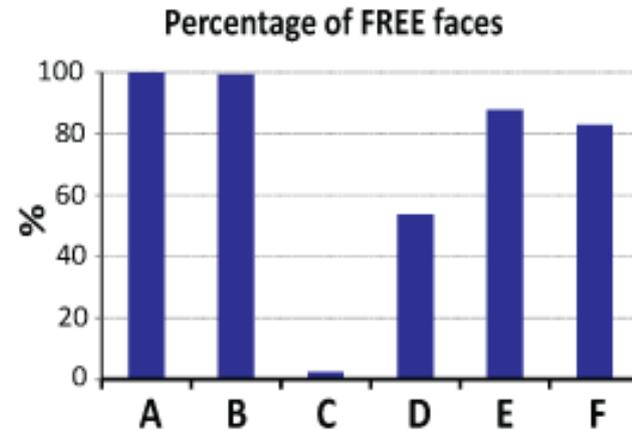
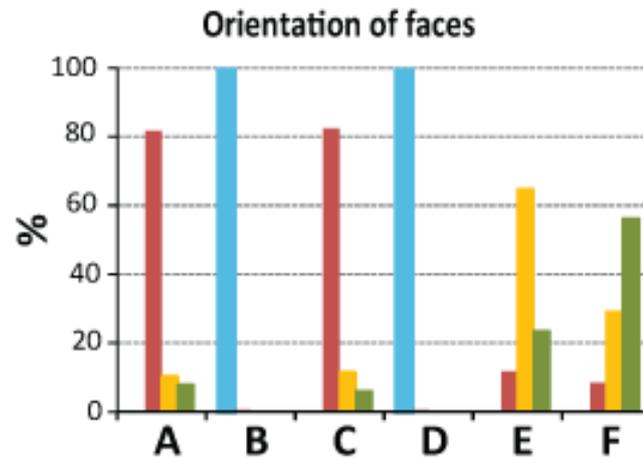
- F1 (bedding)
- F2 (N90)
- F3 (N60)
- F4 (N150)

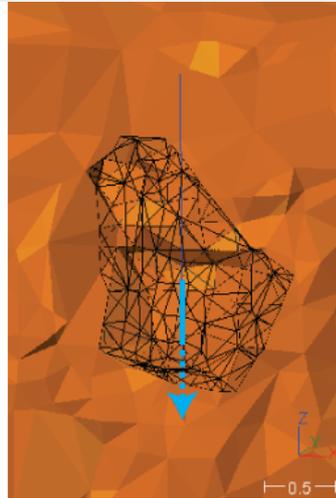
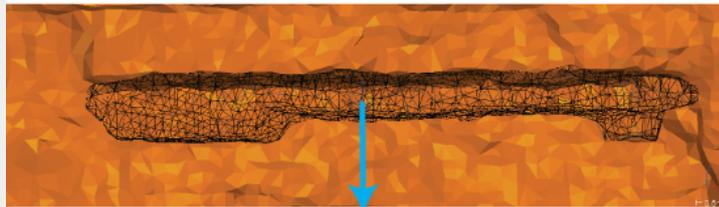
$w$  intersects a jointed face: **Slide**

**Shear strength** of discontinuities is mobilized

$w$  intersects a free face: **Topple (or free fall)**

**Tensile strength** of discontinuities is mobilized
