Vertical geology conference 2014
from remote sensing to 3D geological modelling
February 6-7, 2014

ANALYSIS OF THE POSSIBILITY FOR USING THE RESULTS OF TERRESTRIAL LASER SCANNING (TLS) MEASUREMENTS AND CLASSIFICATION ALGORITHMS OF IMAGES FOR THE ENGINEERING STRUCTURE SURFACE CONDITION ASSESSMENT

Eckertalsperre

Besko

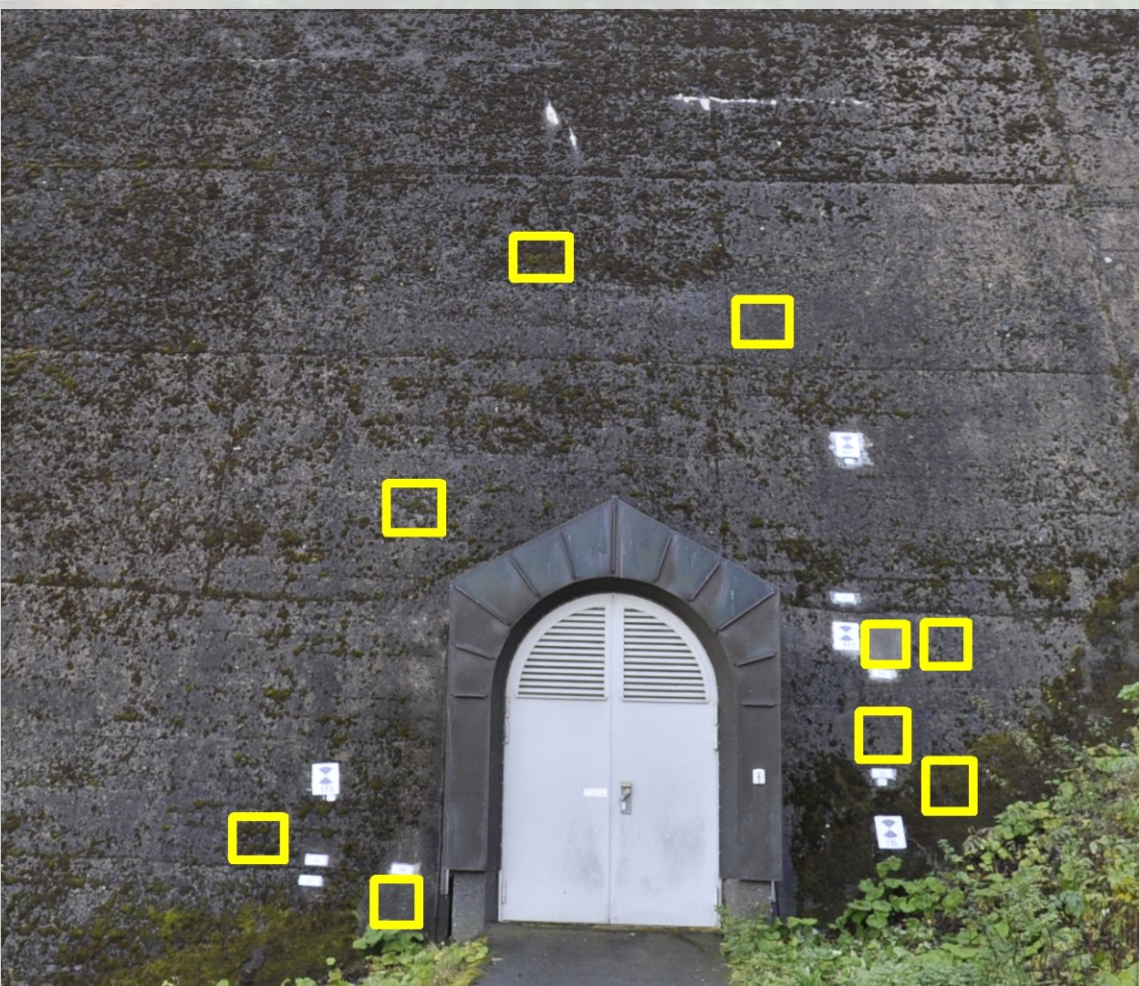
Selected reference sample areas for supervised classification

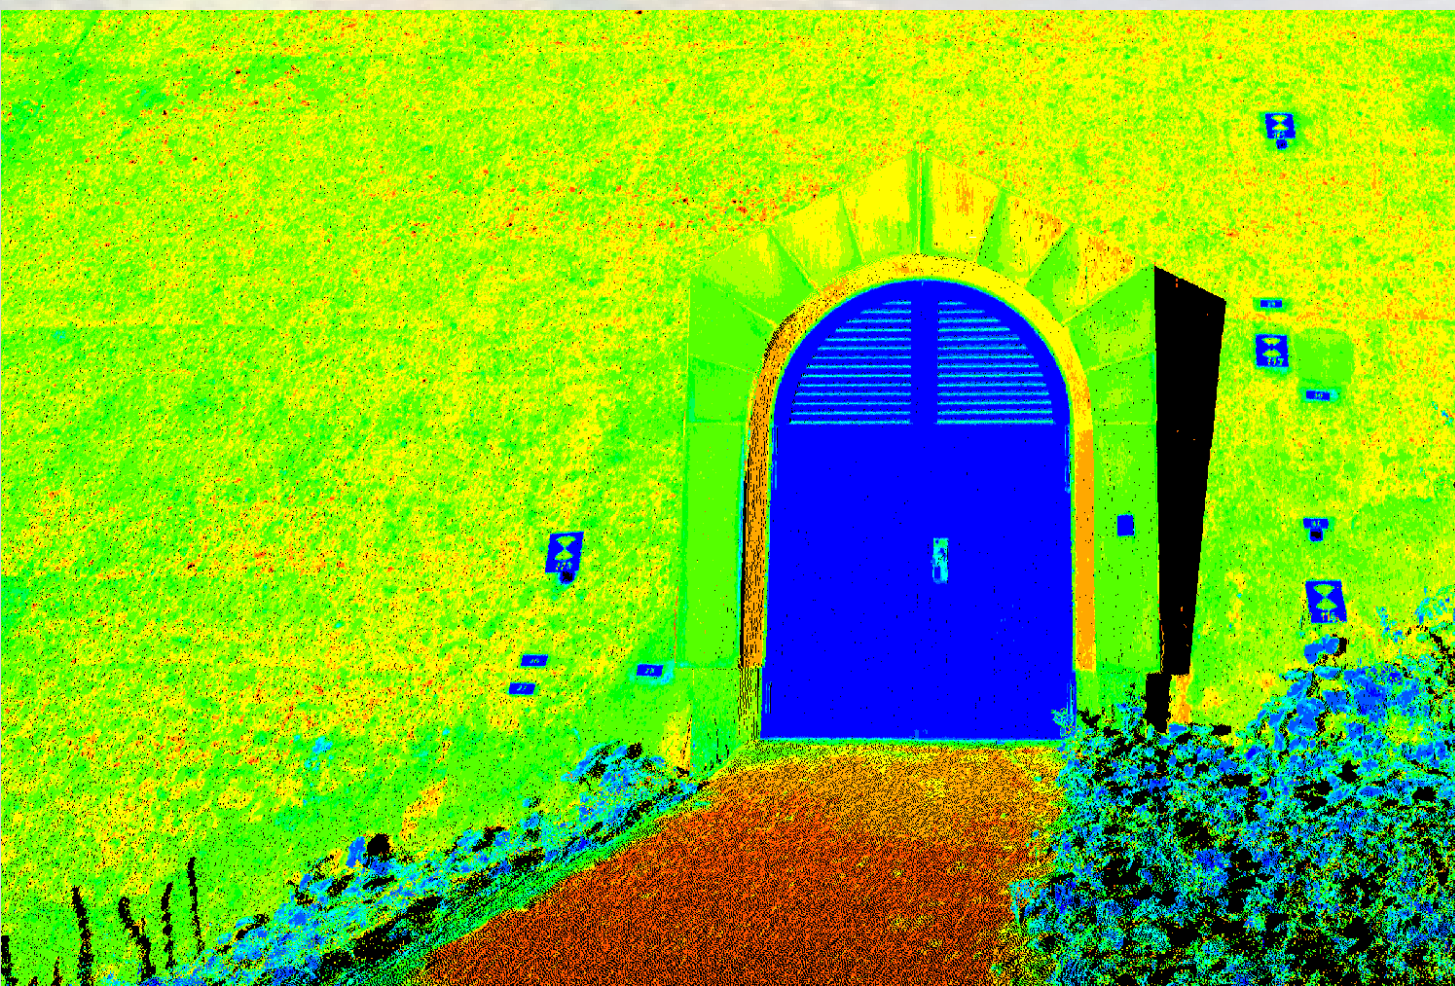
The results of the initial classification of intensity data captured by a TLS (un-supervised method, ISODATA algorithm) – station 501, the downstream surface

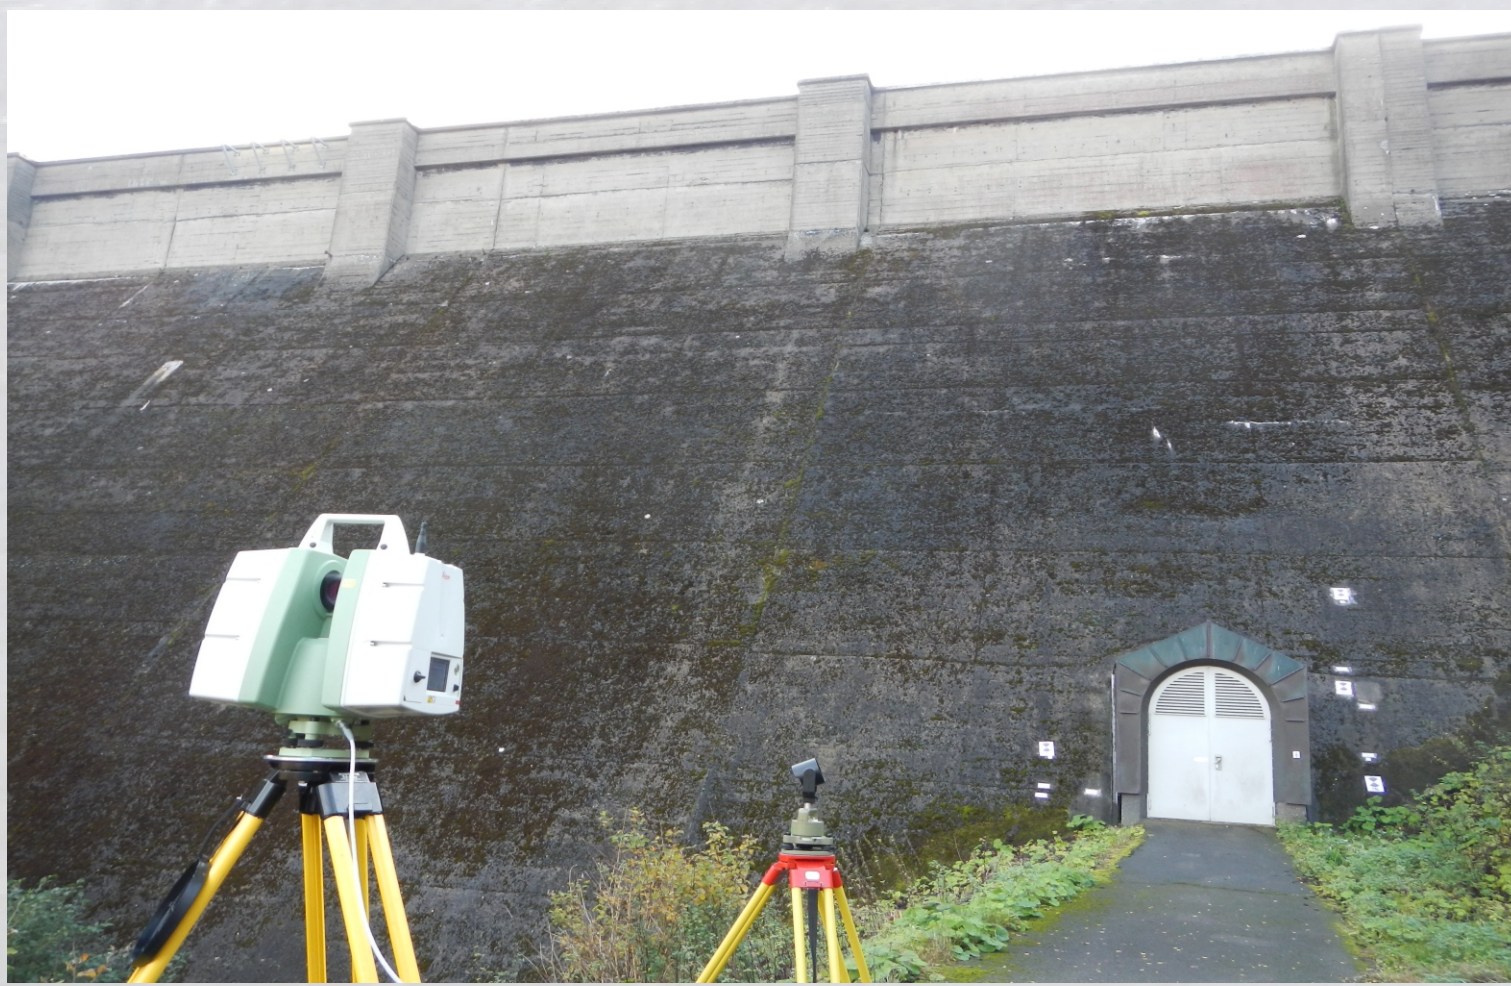
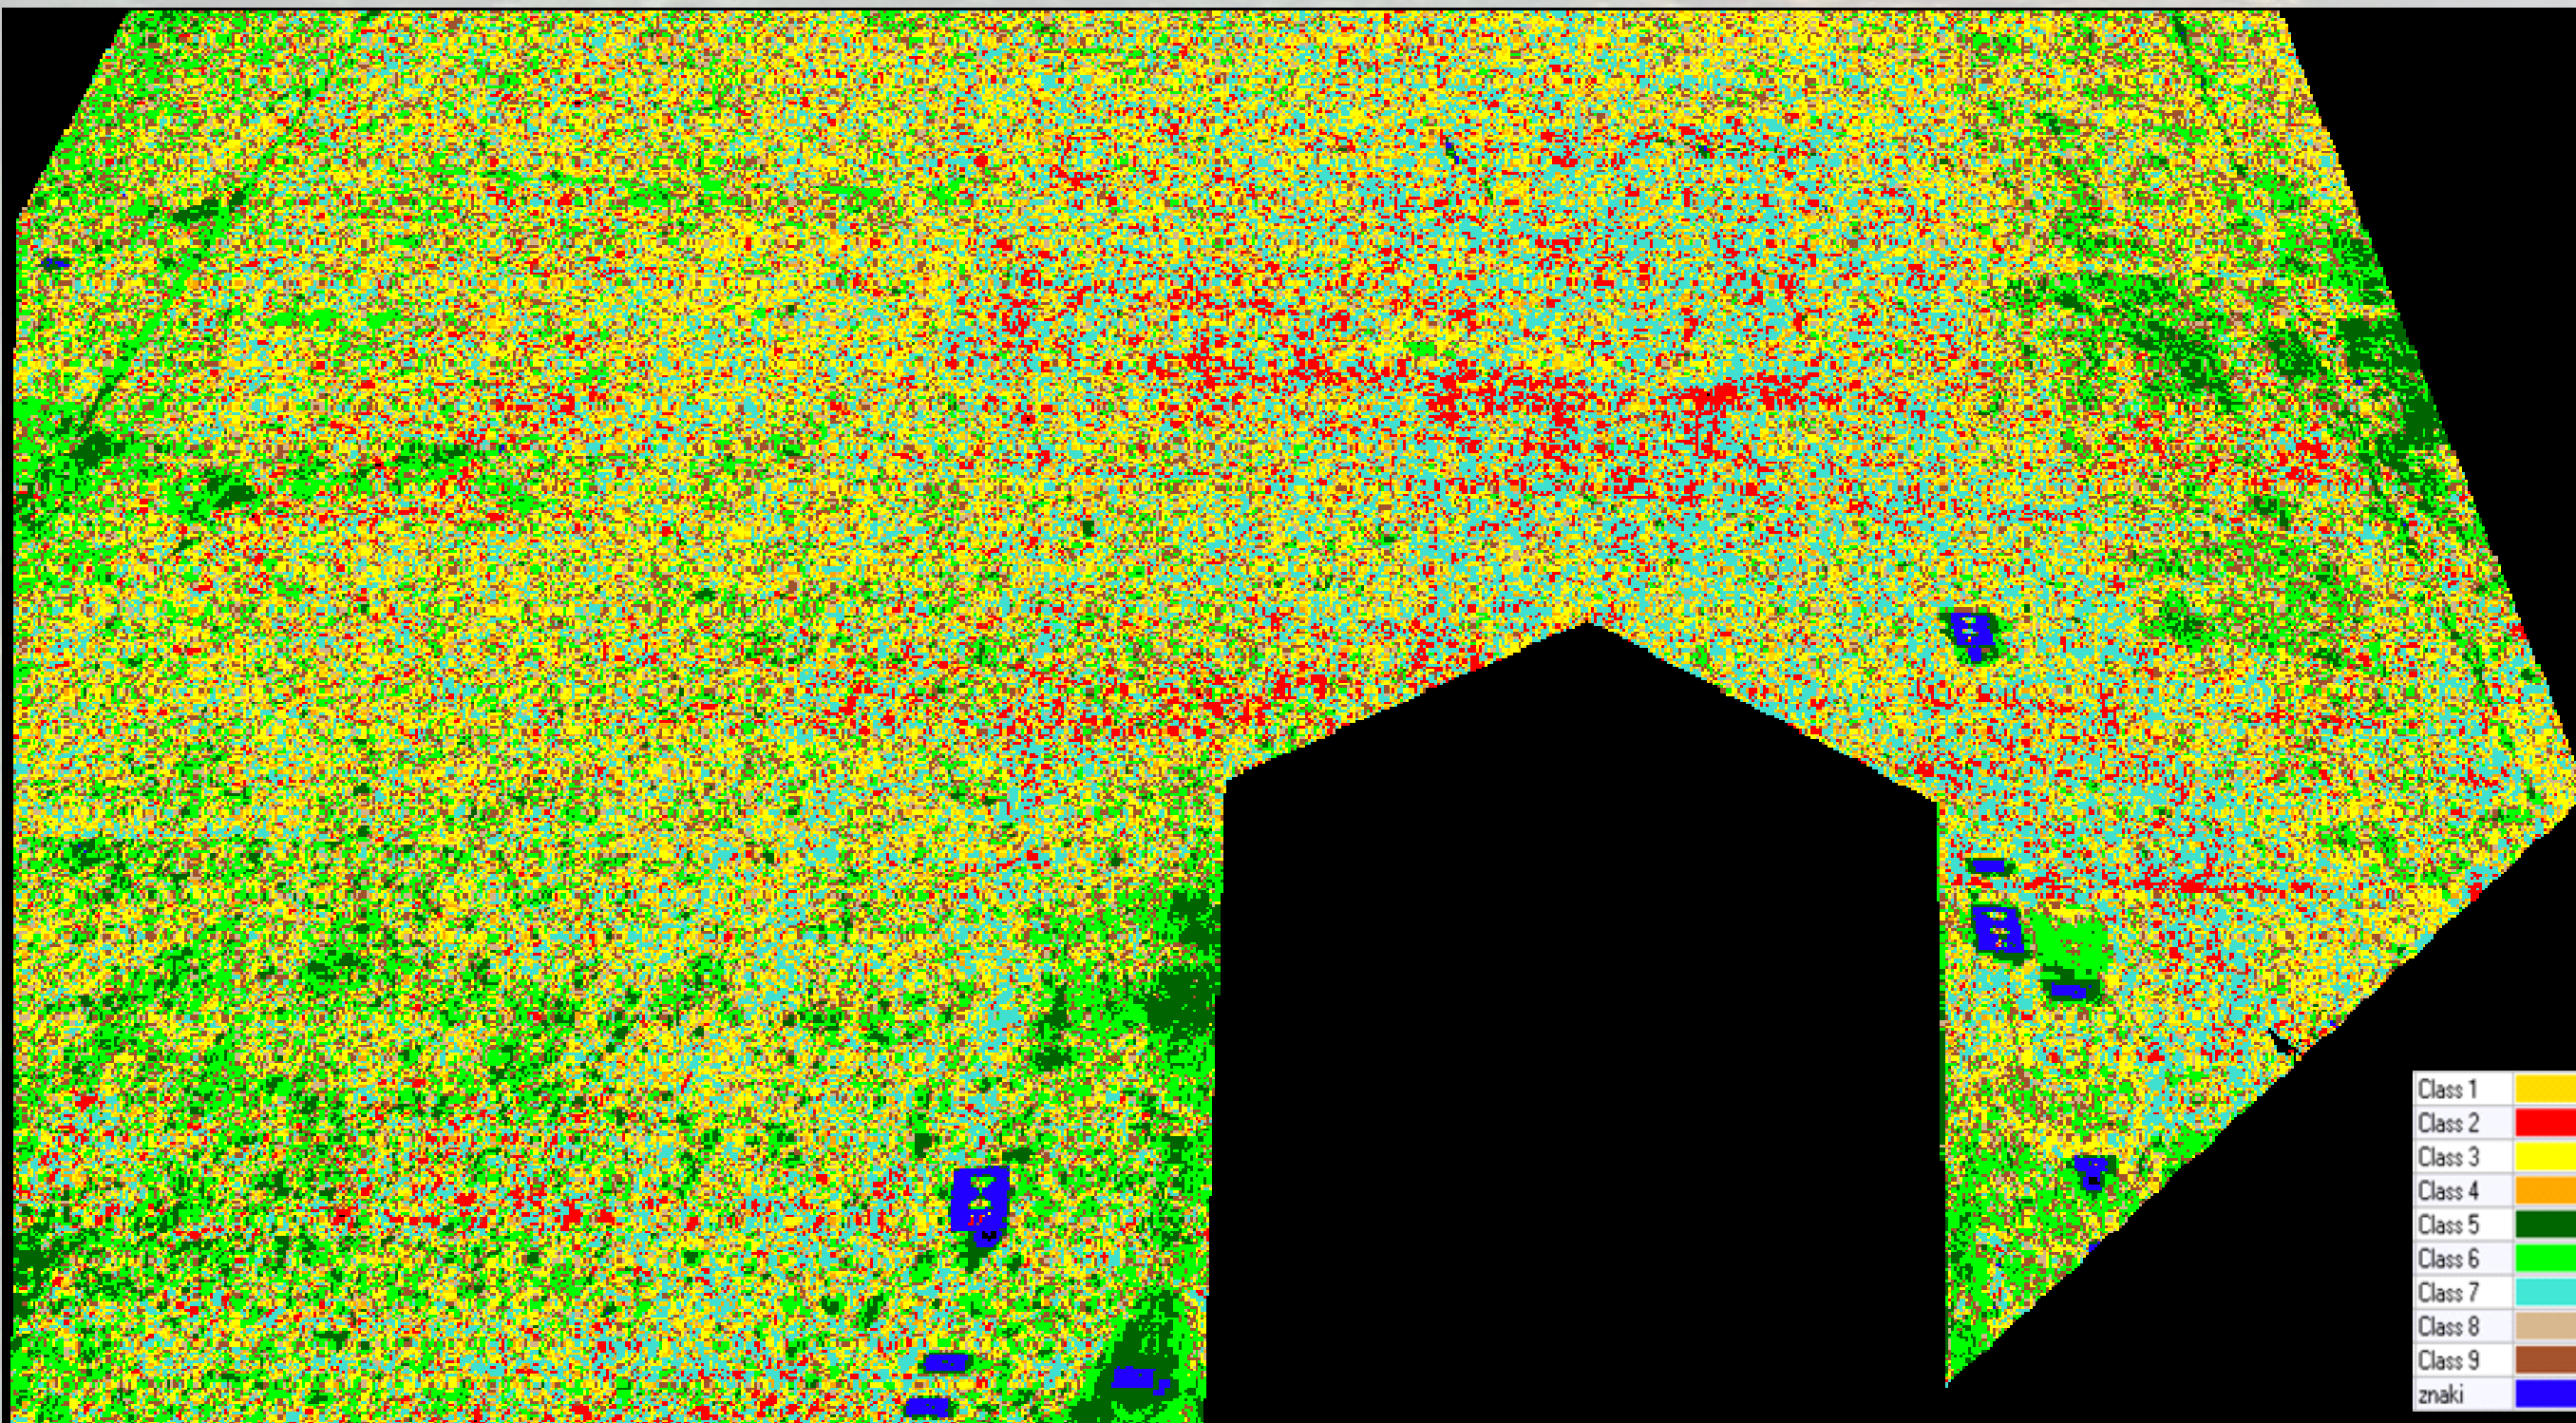
Eckertalsperre - the result of supervised classification algorithm using minimum distance method (9 classes) for bitmap representation of Intensity after the image filtration (mean)

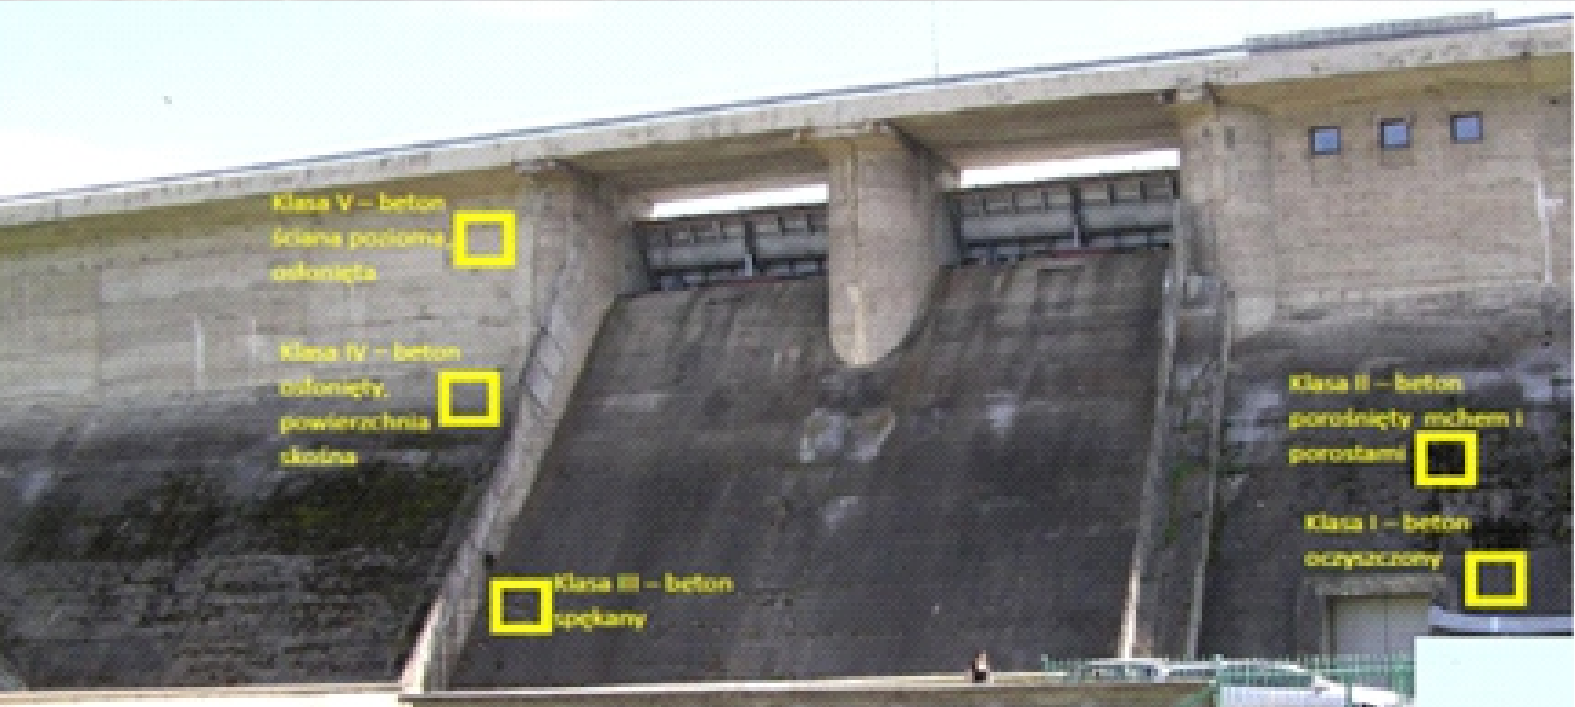
Selected reference sample areas for supervised classification

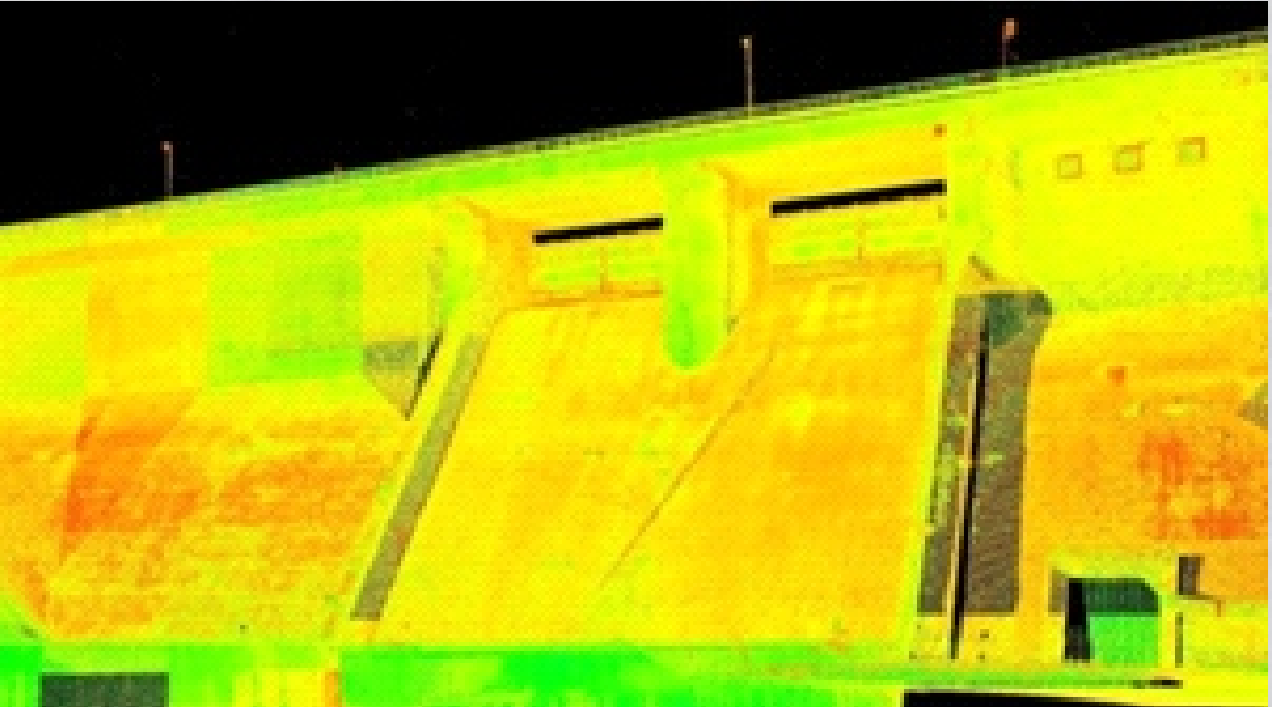
The results of the initial classification of intensity data captured by a TLS (un-supervised method, ISODATA algorithm)

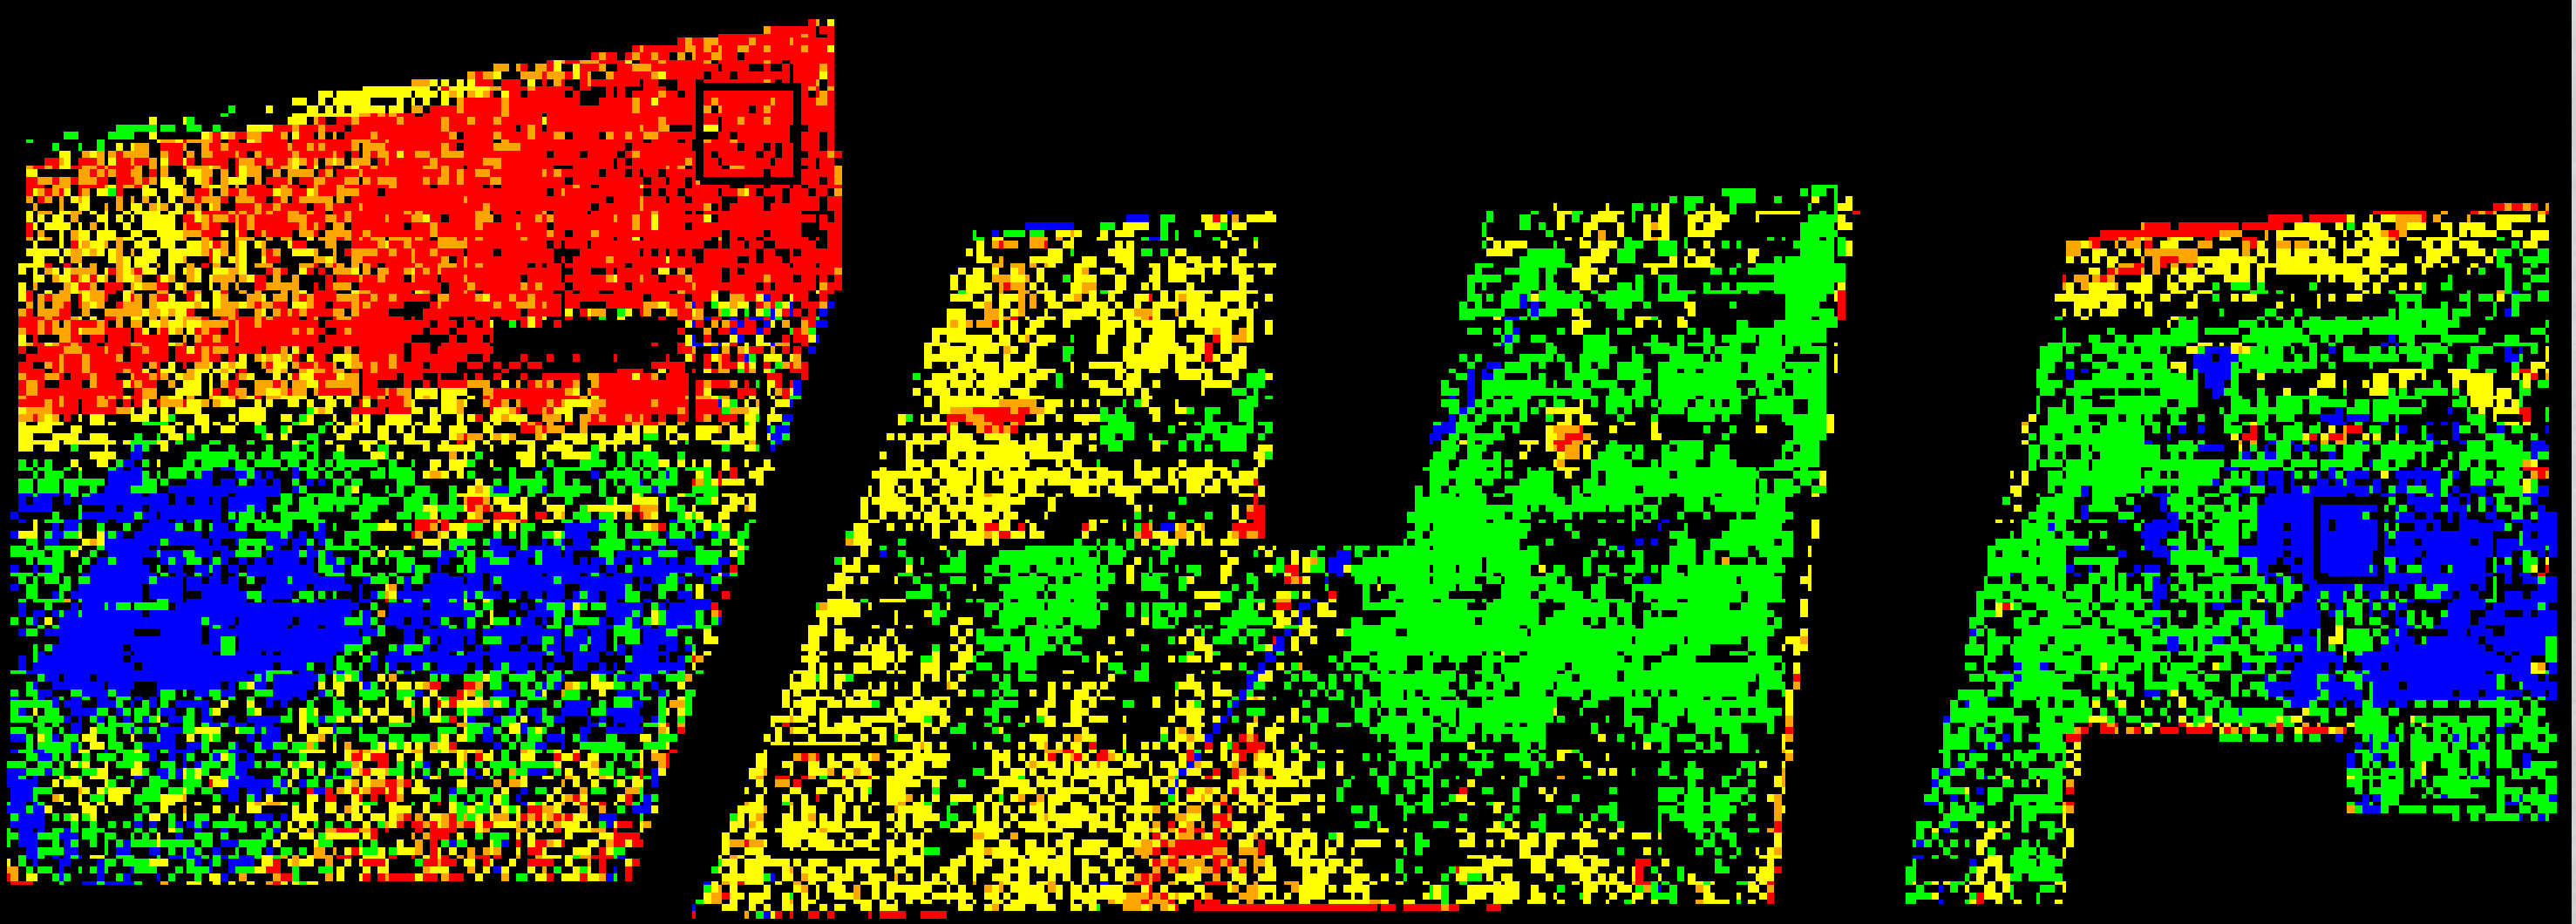
Besko dam - the result of supervised classification algorithm using maximum likelihood method (5 classes) for bitmap representation of Intensity after the degradation pixel size, in black fragments of the concrete dam are presented, which cannot be assigned to any of the classes because of the low probability of belonging to a specified class
